ProTech

Supporting Today's Professional Technician

22-1000 applications clunking noise after replacement

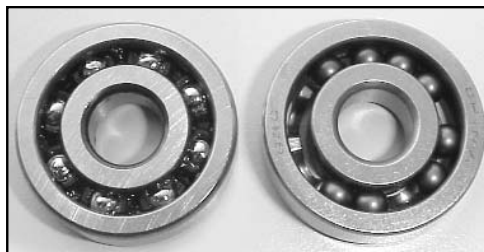
The Rack and Pinion lower pinion bearing can fail due to faulty original bearing.

CARDONE bearing -
balls and inner cage
in proper alignment

OE bearing -
balls and inner cage
out of alignment

CARDONE engineers identified this OE problem in January 2002. By identifying the problem and implementing a different bearing, we provided an improved design solution 2 years prior to GM's announcement.

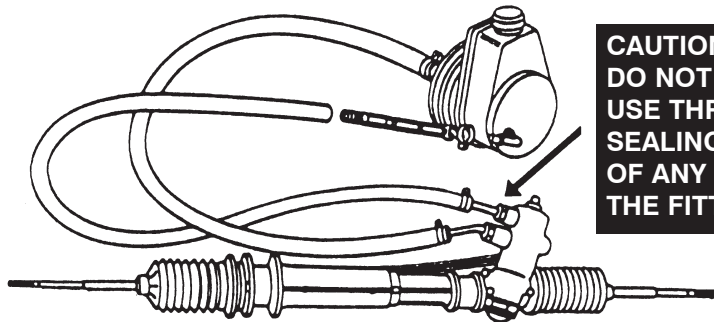
Contamination from defective components or hoses is blocking fluid flow, through the spool valve of the steering unit

When replacing any steering component it is recommended that power steering lines be replaced if more than 4 years old or appear damaged. Also flush the entire system with new fluid to wash away any contaminants. If you do not flush the system and replace lines you could experience a return of the symptoms. Failure to properly service the power steering system will **VOID THE WARRANTY**.

CAUTION:
DO NOT
USE THREAD
SEALING TAPE
OF ANY KIND ON
THE FITTINGS

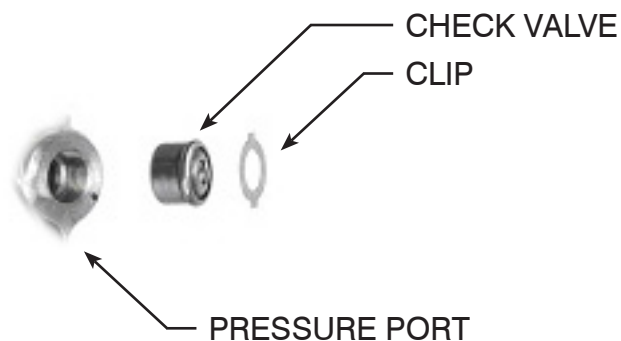
Correctly transferring and installing pressure port check valve.

The original rack and pinion may have a check valve and retaining clip in the pressure port. See graphic below for a typical installation. The valve prevents fluid from backing up into the pump when the engine is shut off. Not all original units have a check valve, but if one is present, it should be transferred to the replacement rack. Note also that they don't always have a retaining clip. The installation will be successful without the clip; it's there to hold the valve in place during installation and to prevent the valve from falling out if the lines are serviced. If the clip is reused, be very careful not to damage port threads. The most important thing is to install the check valve in the pressure port, being careful to orient the valve as shown. CAUTION: Pressure and Return ports are the same thread size. Please refer to ProTech PT 22-0007 to determine which port is the pressure port.

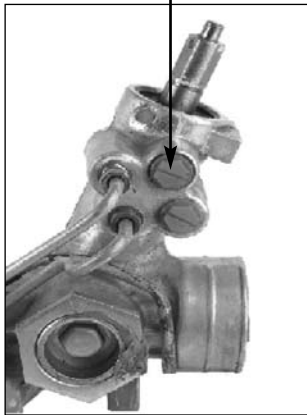
Type 1

Problem: Because ports are the same thread size, the pressure and return hoses can be reversed, causing violent self-steering and damage to the rack.

For part numbers:
22-214, 22-219, 22-228,
22-230, 22-231, 22-235,
22-239, 22-241, 22-242,
22-243, 22-244, 22-246,
22-250, 22-251, 22-252,
22-253, 22-268, 22-276

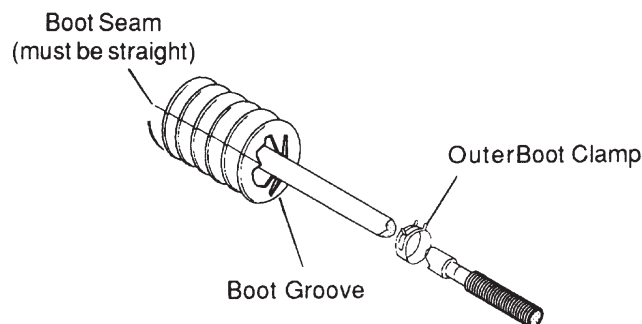
Premature boot (bellows) failure allowing contamination (i.e., water, sand, dirt) to enter the Rack and Pinion, damaging internal components

Boots twisted during front-end alignment adjustments.

1. Remove outer boot clamp.
2. Perform front end alignment
3. Make sure boot seam is straight (not twisted) and boots are in the proper grooves— $\frac{1}{8}$ " groove for plastic (hard) boot and $\frac{3}{4}$ " groove for rubber (soft) boot.
4. Install outer boot clamp.

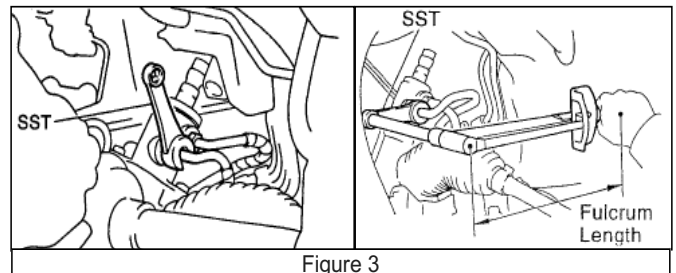
Figure 3

Replacement rack and pinion leaks from the pressure or return port fittings at the housing (see figure 1).

The original fitting O-ring seals were reused or fittings improperly tightened. High heat and pressure make the old seals hard and brittle – this is known as “compression set”. Reusing seals causes leaks because they are unable to conform to the sealing surface. To compound the problem, a technician may assume that the leakage can be stopped if more torque is applied to the fittings – this assumption is INCORRECT. The seal on this type of fitting is held in place and activated by the pre-formed flare and grommet in the hydraulic line itself (see figure 2). Over-tightening the fittings can lead to stripped port threads and cracked castings.

1. Replace original O-rings with the supplied new O-rings found in the installation kit attached to your rack & pinion.
2. Follow all OE torque and installation specifications and practices (Reference the vehicle's OE Service Manual for installation specifications).
3. Use the correct tools for the installation. For these applications, Toyota suggests certain tools (SST, see figure 3 for typical installation) that will assist and ensure correct installation of this rack & pinion. Refer to the vehicle OE Service Manual for individual installation specifications.

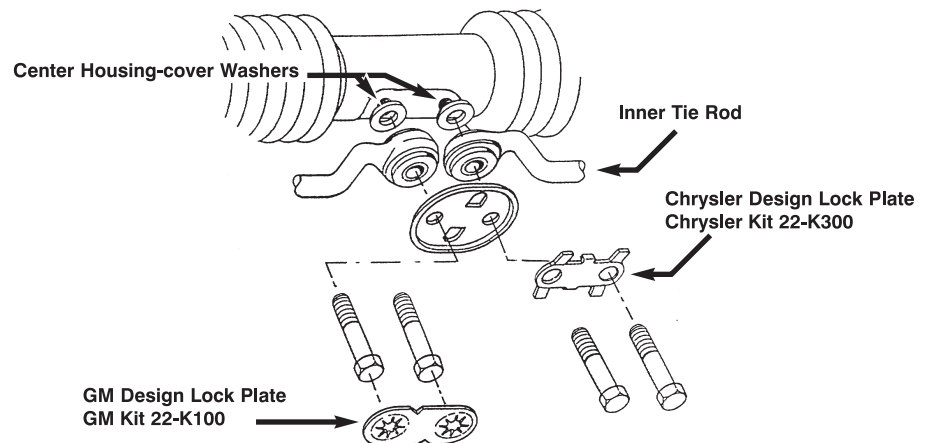
Noisy operation, stiff or binding steering, or damaged housing.

After replacing inner tie rods or replacing the rack & pinion the inner tie rod mounting hardware could have been improperly installed or not used.

LOCKING PLATES DESIGNS ARE NOT INTERCHANGEABLE

Only use original design mounting hardware and fasteners when installing rack & pinions. Never omit mounting components and always install unit exactly to original specifications and procedures. Failure to install both center housing cover washers or to install the wrong locking plate will allow bolts to bottom in housing causing binding and damage to the unit. (Scan code to watch video tip). CARDONE Service Plus Rack & Pinion inner tie rod end repair kits for GM and Chrysler CTO units are now available. Each kit contains all the parts necessary to do the job right the first time (GM Kit 22-K100; Chrysler Kit 22-K300).
