ProTech

Supporting Today's Professional Technician

27-7617, 8412, 8413 Clunking Noise After Replacement

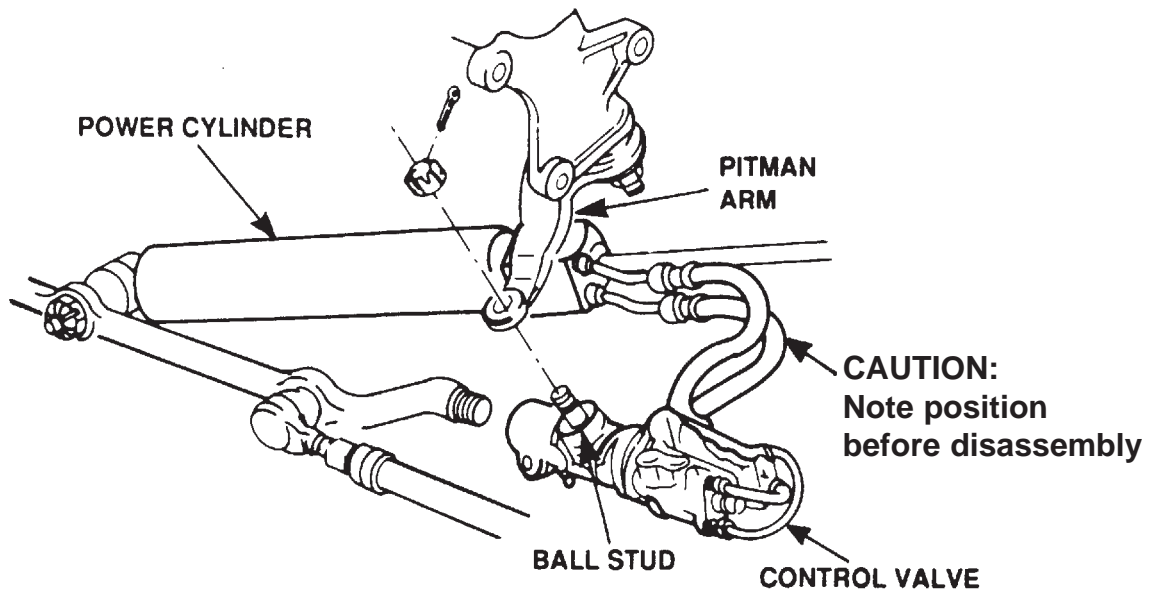
Problem: After replacing the power steering unit, the vehicle steers violently from side to side by itself.

Solution: When installing a control valve or power cylinder, be extremely careful not to cross the pressure lines to the cylinder. Failure to do so can lead to a malfunction and could result in bodily injury and VOID WARRANTY.

Caution: When replacing any part in the power steering system, ALWAYS FLUSH THE SYSTEM USING APPROVED POWER STEERING FLUID AND REPLACE HOSES! New parts can become contaminated with residues from existing components possibly causing malfunctions.

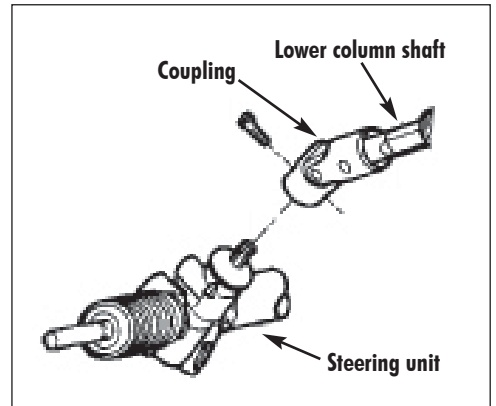
Possible steering coupling universal joint failure.

Steering binding is often mistakenly diagnosed as a defective steering unit or power steering pump. Further diagnosis may reveal that it is a frozen or sticking universal coupling on the steering shaft that connects to the unit input shaft. Most couplers are sealed and cannot be lubricated. Exposure to weather and road conditions causes them to dry out and rust, shortening their life.

1. Disconnect the coupling from the steering unit input shaft (usually attached with a pinch bolt).
2. After sliding the coupling off of the input shaft, rotate the coupling U-joint in both directions to feel for any binding or tight spots.
3. If it is binding or tight, replace the coupling with a quality replacement.
4. If it is free and no binding is found, re-install coupling and continue diagnosis of other steering linkage and all mechanically-connected components. If all component test results are good, continue with diagnosis of hydraulic system including pressure tests. Refer to your vehicle's service manual for repair procedures, specs and possible TSB's.

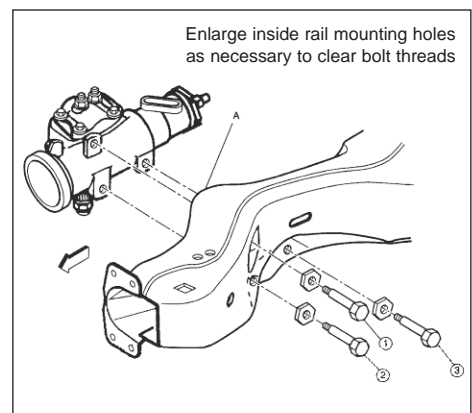
The lower control arm may be striking the steering knuckle during full-turn-type maneuvers, causing the crunch sound. Slight movement between the steering gear attaching bolt threads and the frame rail inboard steering gear attaching holes may cause the popping sound.

Popping sound: Examine the frame rail inboard steering gear attaching holes for evidence of bolt thread contact. Enlarge inboard mounting holes that show contact only enough to allow the bolt threads to be free in the frame holes (use appropriate tools for the job). Reinstall the gear, but do not tighten bolts 1, 2 and 3 (see figure 1). Then perform the following steps:

1. Start the vehicle and cycle the steering lock to lock several times, allowing the gear to reposition itself.
2. Torque attaching bolts (1, 2 and 3) to 70 ft. lbs. (95 Nm).

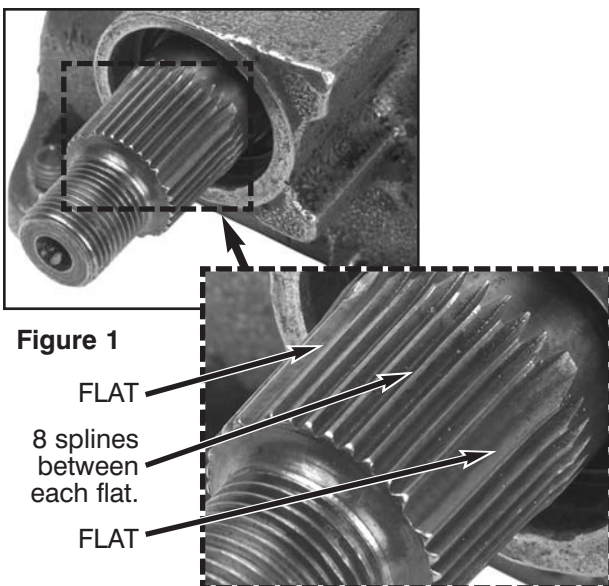
Figure 1.

27-7565 has a total of 32 splines (4 flats with 8 splines between flats)

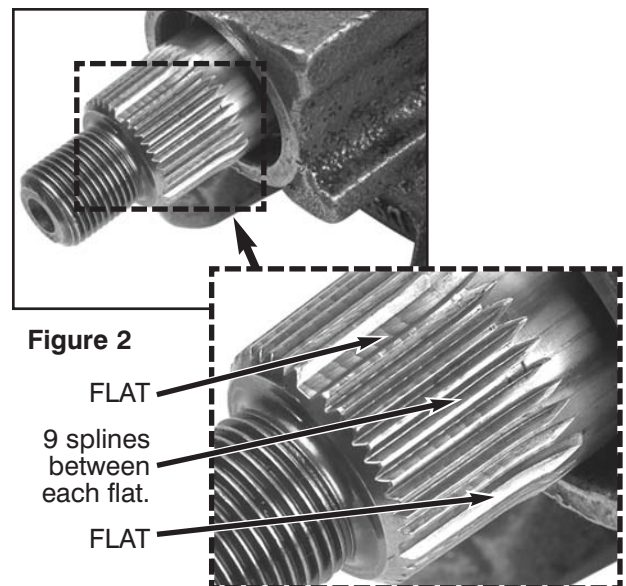
27-7569 has 36 splines (4 flats with 9 splines between flats) **Figure 2.**

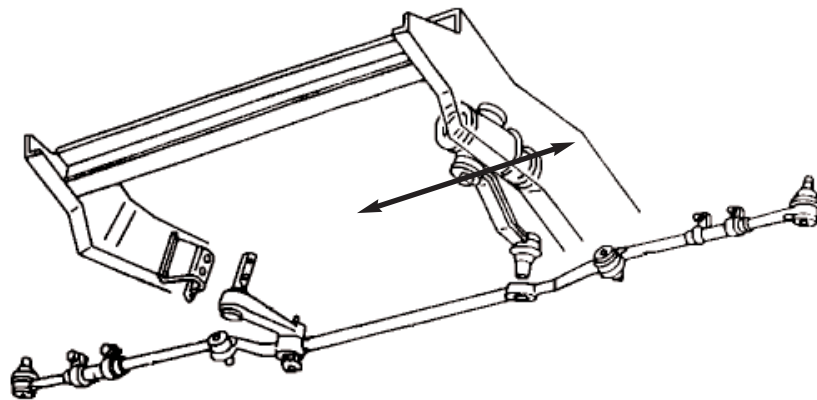
The majority of power steering gears are built with a roller bearing that supports the pitman shaft and allows it to rotate; the force that is placed on the pitman arm transfers to the pitman shaft. This roller bearing is designed to absorb that type of movement, however, for some applications a noticeable amount of lateral movement can be observed (see graphic below). This is a normal characteristic of a roller bearing when used in this application.

- This is not the result of a defective steering gear and/or other related internal steering gear components.
- This type of play is not related to excessive steering wheel play or vehicle drift and wander.

Diagnosis and repair of steering wheel play, vehicle drift or vehicle wander may be attained by referencing your vehicle's service manual and technical service bulletins related to steering problems. For example, see Chrysler (Dodge truck) TSB 05-04-99.

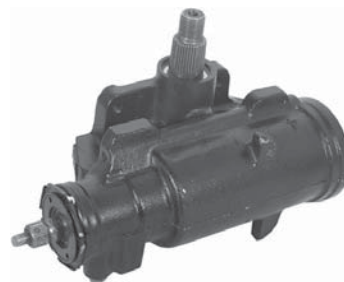
After installation of a replacement unit, input shaft free-play seems excessive.

Unit must be tested under pressure from power steering pump.

Most steering gears will have more free-play around center until power steering pressure is applied to the gear. Follow the test steps below when testing for free-play.

1. Gear must be on mechanical center. Determine center by dividing total turns lock-to-lock in half. If gear is not centered there will be excessive play.
2. Start engine. Be sure pump is producing proper pressure and flow through the gear. If gear is not under pressure, the input shaft (which consists of a torsion bar within the spool valve) will produce play. When under pressure, the fluid compensates. With no pressure applied, input play can exceed 5 degrees.
3. Test unit.

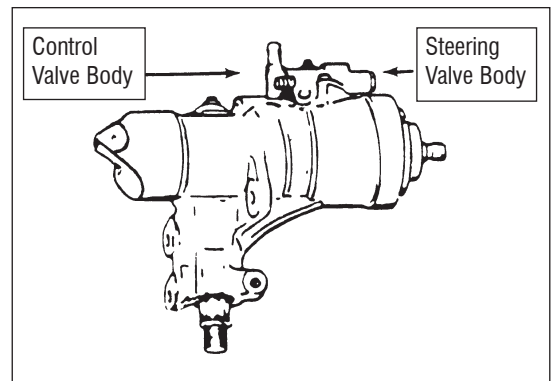
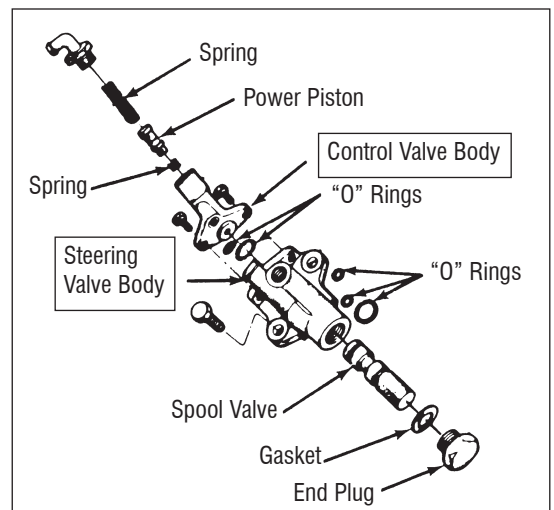
Whine or growl noises.
Poor steering return.
Hard steering or lack of assist.
Binding in steering or leakage.

Sticking Power Piston or restriction in Control Valve Body.

Disassemble *Control Valve Body*. Clean & inspect all parts. Flush system thoroughly and bleed according to manufacturers specifications.
