WATER CONTAMINATION DUE TO FLOODING CONDITIONS

SERVICE/TECHNICAL

DATE: September 13, 2017

TO: All Dana Heavy Axle Customers

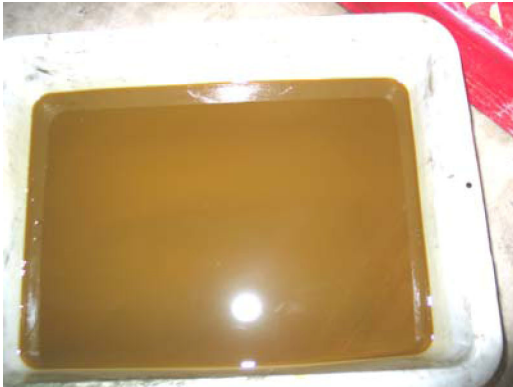
1. Place a CLEAN catch pan under the drive axle to be inspected. If the lube is not contaminated, it can be reused.
2. Remove the drain plug or bolt to drain lube from housing.
3. Visually inspect the lube for a milky appearance. See example below. If the appearance of the lube is questionable a "crackle test" can be performed to identify the presence of water.

Water Contaminated Lube – Milky

4. If water is indicated, the carrier assembly must be completely disassembled and a visual inspection of all bearings and machined surfaces should be performed. Components showing contamination damage including rust and/or pitting should be replaced, never repaired.
5. Pinion, input, and output seals should be replaced. Do not reuse.

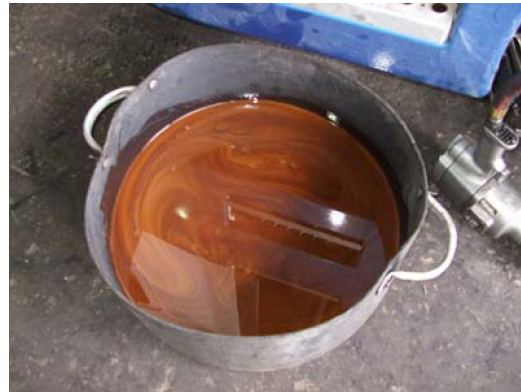
Water Contaminated Lube – Milky

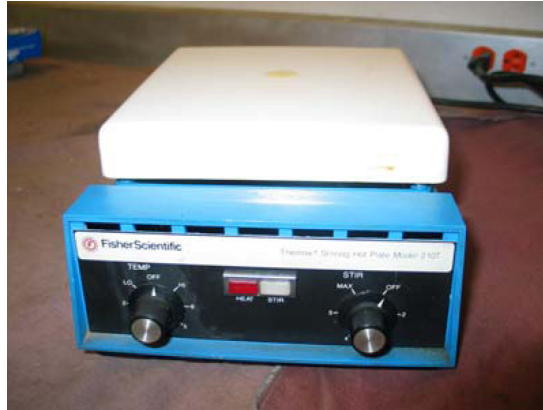
Hot Plate

Note: A crackle test can be performed by applying a couple drops of suspect lube on to a heated surface such as a hot plate. The surface should be greater than 400 degrees. If the lubricant pops and/or crackles on the heated surface, there is water in the lube. If the lube just smokes, no water is present.
