ProTech

Supporting Today's Professional Technician

22-1000 applications clunking noise after replacement

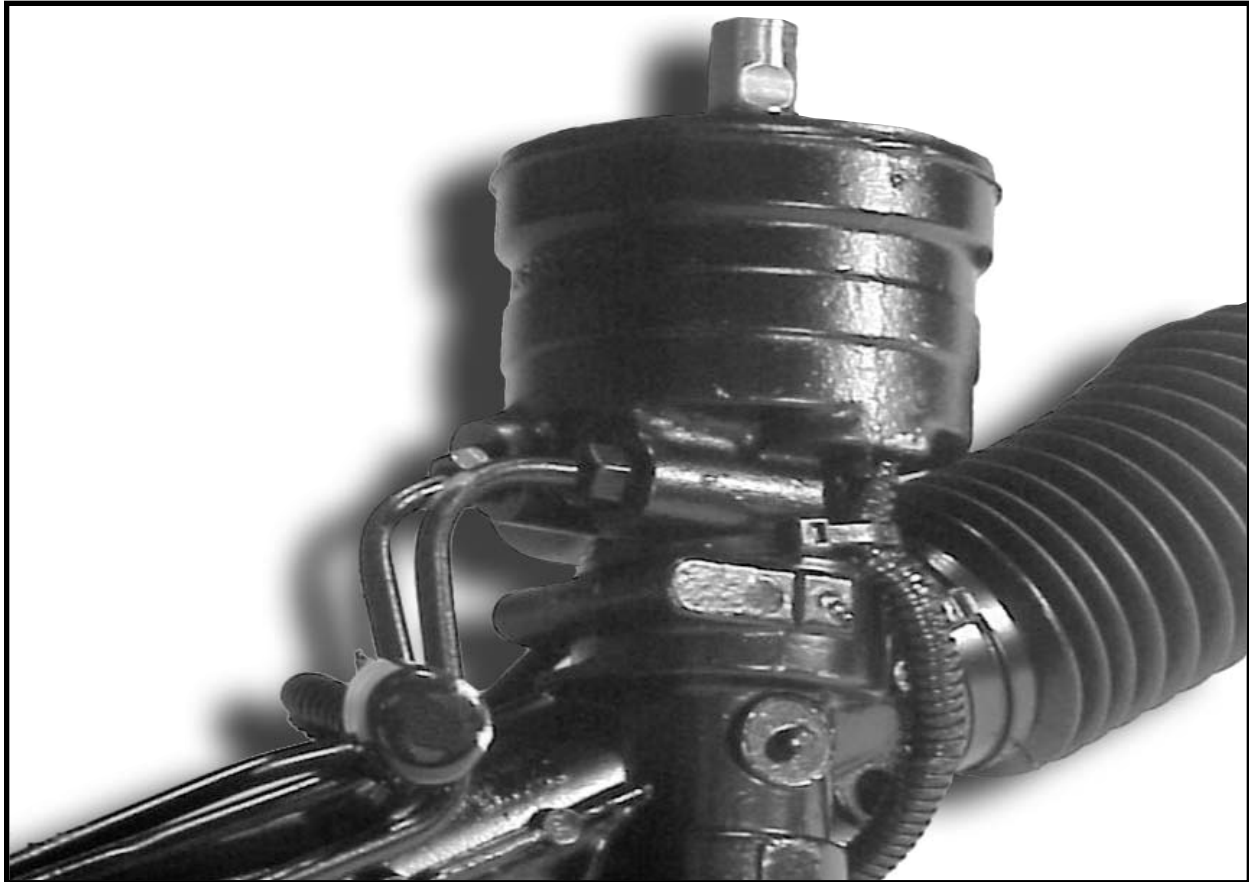
The Rack and Pinion lower pinion bearing can fail due to faulty original bearing.

OE bearing -
balls and inner cage
out of alignment

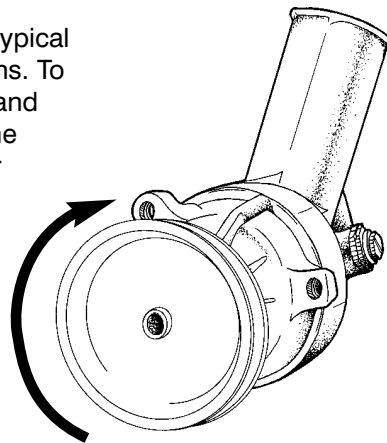
Power Steering Pump failure due to initial startup with a dry pump.

After final factory testing, power steering fluid is drained from the pump. If after installation the pump is run dry, it will fail.

Hand-prime the pump before starting (especially if the pump has a remote reservoir). Before running the pump be sure to fill reservoir to operating level (please refer to our other ProTechs that describe proper flushing and hose maintenance). Hand-turn pulley in correct direction until fluid pumps from the pressure port. Refill reservoir as necessary, complete installation and bleed system per vehicle manufacturer instructions.

Rotation shown is typical for most applications. To prime the pump, hand turn the pulley in the proper direction for your vehicle.

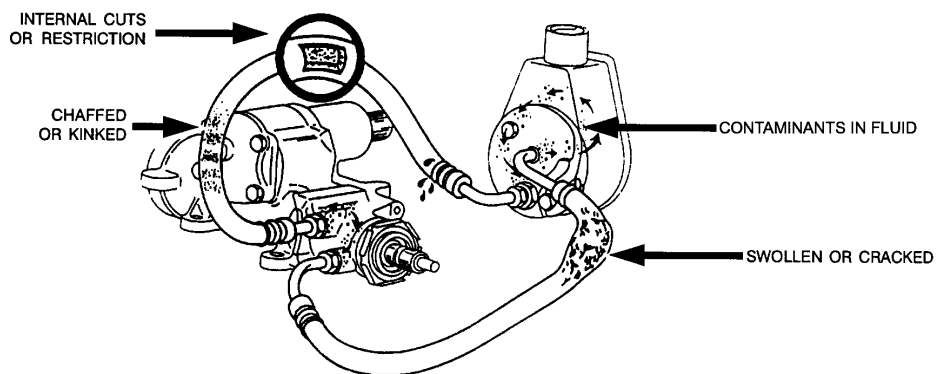
Replacement rack and pinion leaks from the pressure or return port fittings at the housing (see figure 1).

The original fitting O-ring seals were reused or fittings improperly tightened. High heat and pressure make the old seals hard and brittle – this is known as “compression set”. Reusing seals causes leaks because they are unable to conform to the sealing surface. To compound the problem, a technician may assume that the leakage can be stopped if more torque is applied to the fittings – this assumption is INCORRECT. The seal on this type of fitting is held in place and activated by the pre-formed flare and grommet in the hydraulic line itself (see figure 2). Over-tightening the fittings can lead to stripped port threads and cracked castings.

- 8) Be sure fluid in pump reservoir is at proper operating level.
- 9) Start the engine and turn the steering wheel from side to side 2 to 4 times to bleed the system.

- 10) Refill reservoir to proper level if necessary.
- 11) Check for smooth assist, excessive noise, connections for leakage and system for proper operation.

CARDONE recommends replacing flexible power steering lines that are more than 4 years old.
